# Engineering Innovations

# Propulsion

## **Space Shuttle Main Engine**

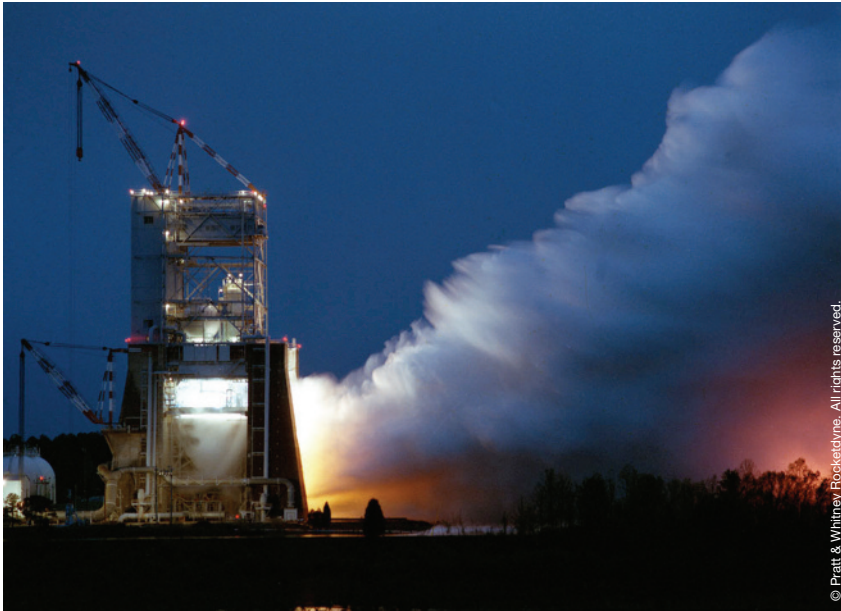
*The Technology Test Bed Space Shuttle Main Engine test program was conducted at Marshall Space Flight Center, Alabama, between September 1988 and May 1996. The program demonstrated the ability of the main engine to accommodate a wide variation in safe operating ranges.*

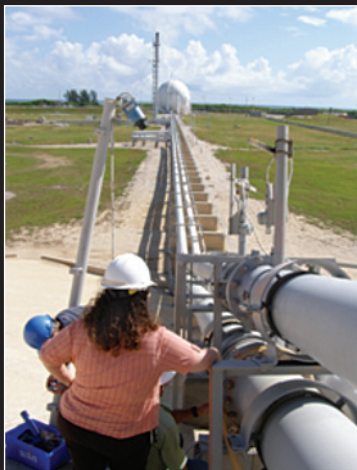
*Hydrogen-sensing tape applied to the Orbiter midbody umbilical unit during fuel cell loading for STS-118 through STS-123 at Kennedy Space Center, Florida.*

*Hydrogen-sensing tape application at liquid hydrogen cross-country vent line flanges on the pad slope.*

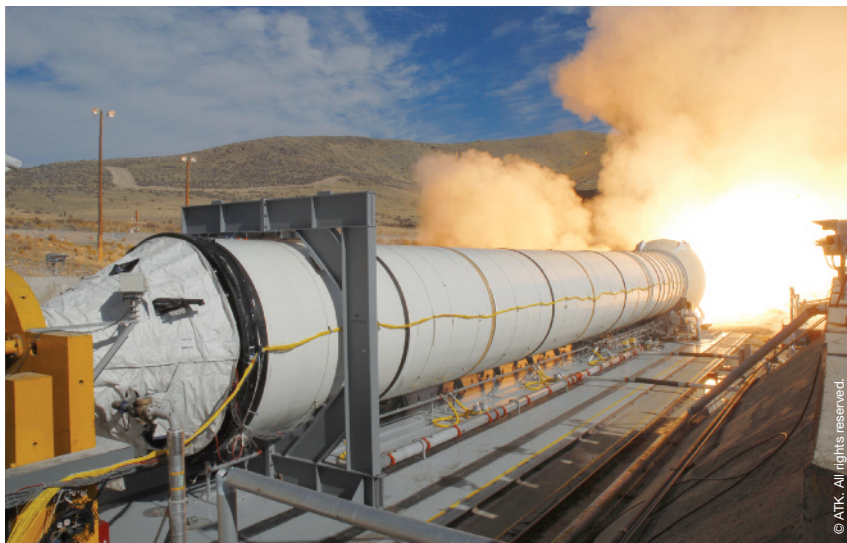
*The two shuttle reusable solid rocket motors, which stood more than 38 m (126 ft) tall, harnessed 29.4 meganewtons (6.6 million pounds) of thrust. The twin solid-fueled rockets provided 80% of the thrust needed to achieve liftoff.*

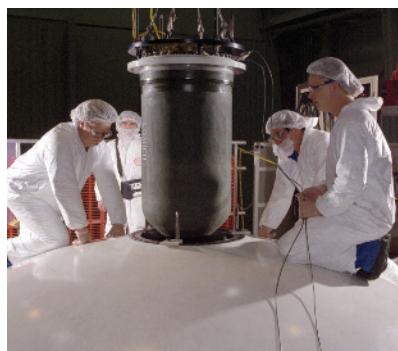
*Technicians shown installing igniter used to initiate the propellant burn in a forward motor segment. The igniter was a small rocket motor loaded with propellant that propagated flame down the bore of the motor.*

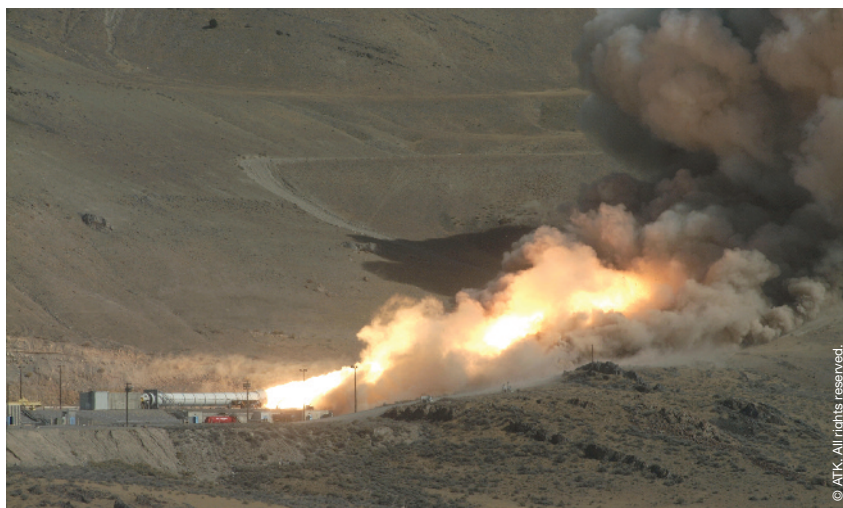
*In Utah, rigorous test program included 53 reusable solid rocket motor ground tests between 1977 and 2010. Spectators flocked by the thousands to witness firsthand the equivalent of 15 million horsepower safely unleashed from a vantage point of 2 to 3 km (1 to 2 miles) away.*

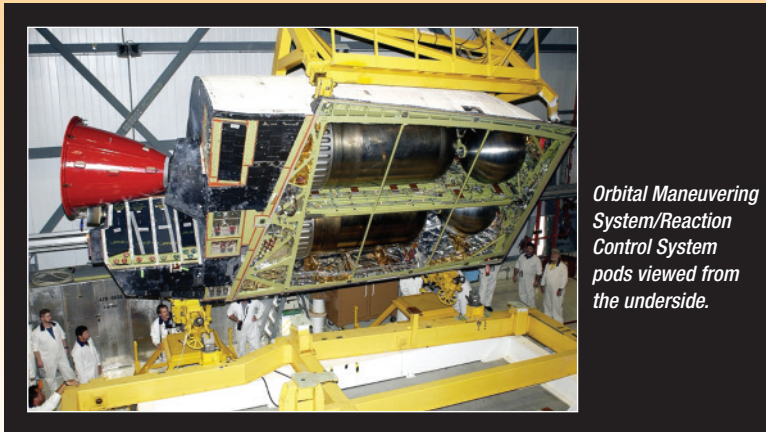
### Orbital Maneuvering System/Reaction Control System

*Orbital Maneuvering System/Reaction Control System pods viewed from the underside.*

NASA ultimately selected monomethylhydrazine as the fuel and nitrogen tetroxide as the oxidizer for this system. As these propellants were hypergolic—they ignited when coming into contact with each other—no ignition device was needed. Both propellants remained liquid at the temperatures normally experienced during a mission. Electrical heaters prevented freezing during long periods in orbit when the system was not in use.
